## Background Information on Beaver Creek, Stanley Park

## Introduction

The purpose of this project is to propose a technical solution to solving two fish barriers currently preventing salmonid access into Beaver Creek. This is in keeping with SPES's mission to *promote awareness of and respect for the natural world and play a leadership role in the stewardship of Stanley Park through collaborative initiatives in education, research and conservation*, as well as the Park Board's values of maximizing biodiversity and respecting cultural integrity.

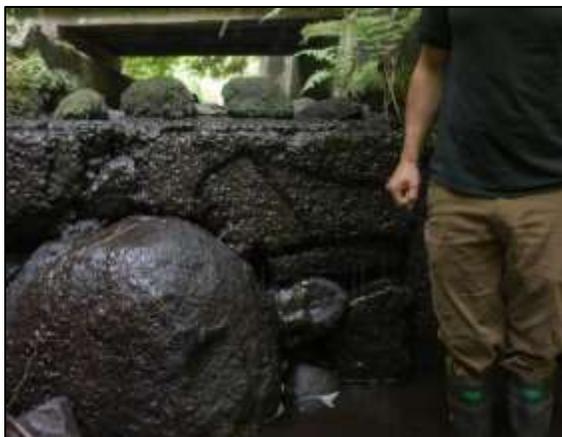
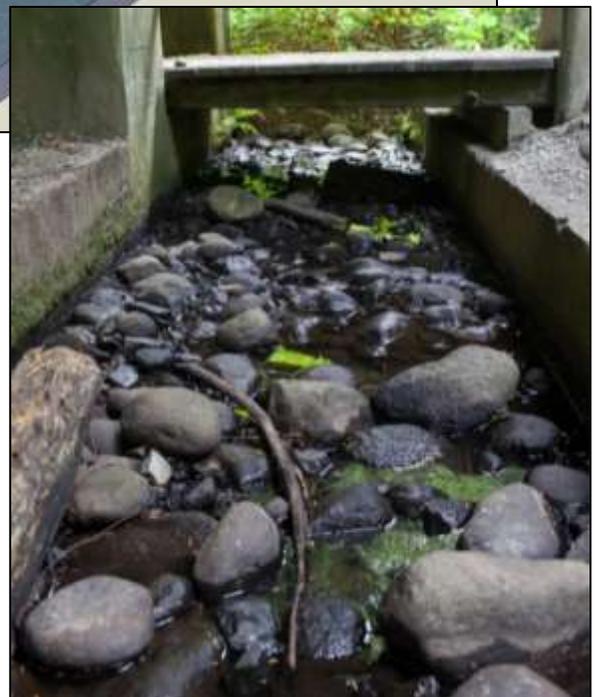
### Pipeline Road bridge waterfall

- 1.38m wide
- 1.1m drop from top of falls to creek bed
- 7.8m from beginning of fish channel upstream to deepest point below waterfall
  - $-20^\circ$  slope (1.5m drop) from top start of fish channel to creek bed below waterfall.

- Install interpretive signage
- Remove invasive species and plant native species
- Fish Barriers
  - Water control structure under Pipeline Road bridge requires a depth of 1.25 times the height of the obstruction to create ideal leaping conditions.

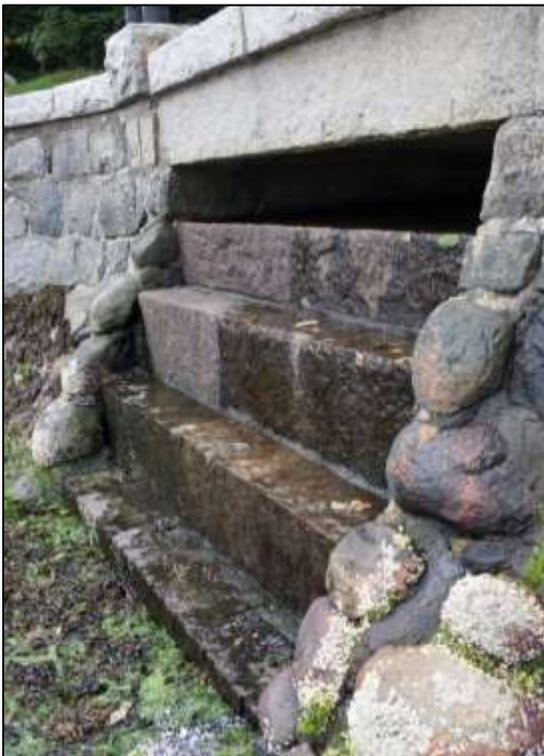
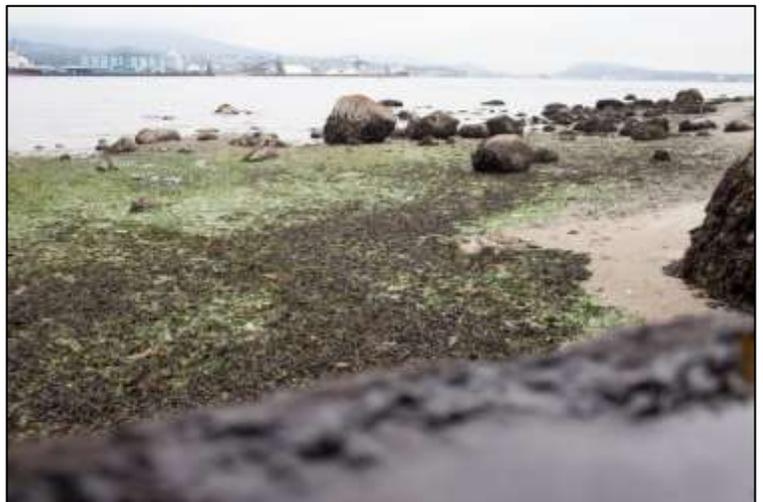
## Seawall Outflow

- Opening dimensions:
  - 30cm height and 3.6m wide
- Staircase dimensions (3.6m wide):
