Beaver Lake Bog Restoration Report

Date: 24 January 2012

Part 1: Baseline Bog Inventory Report and Photo Documentation

Part 2: Bog Restoration methodology

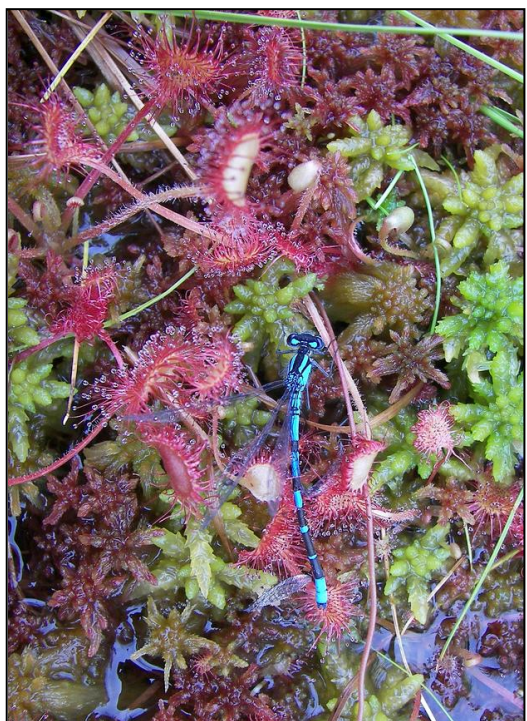
The round-leaved sundew is a carnivorous plant that derives most of its nutrients from trapping and consuming insects such as this damselfly. These plants appear adapted to grow in places where the soil is poor in nutrients, especially nitrogen.

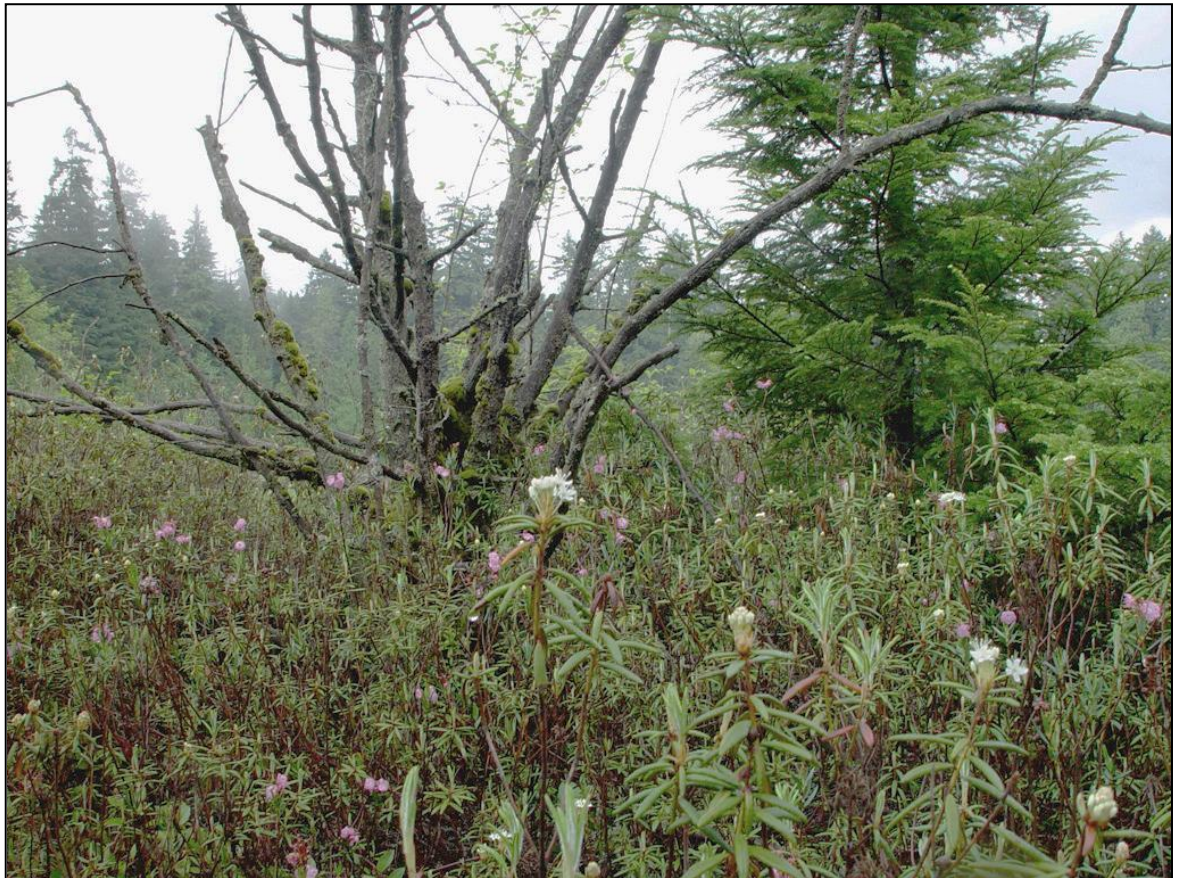
Figure 3: View of bog, facing north, in 2002. Note the purple flowers of bog laurel and the white flowers of Labrador tea in the foreground.

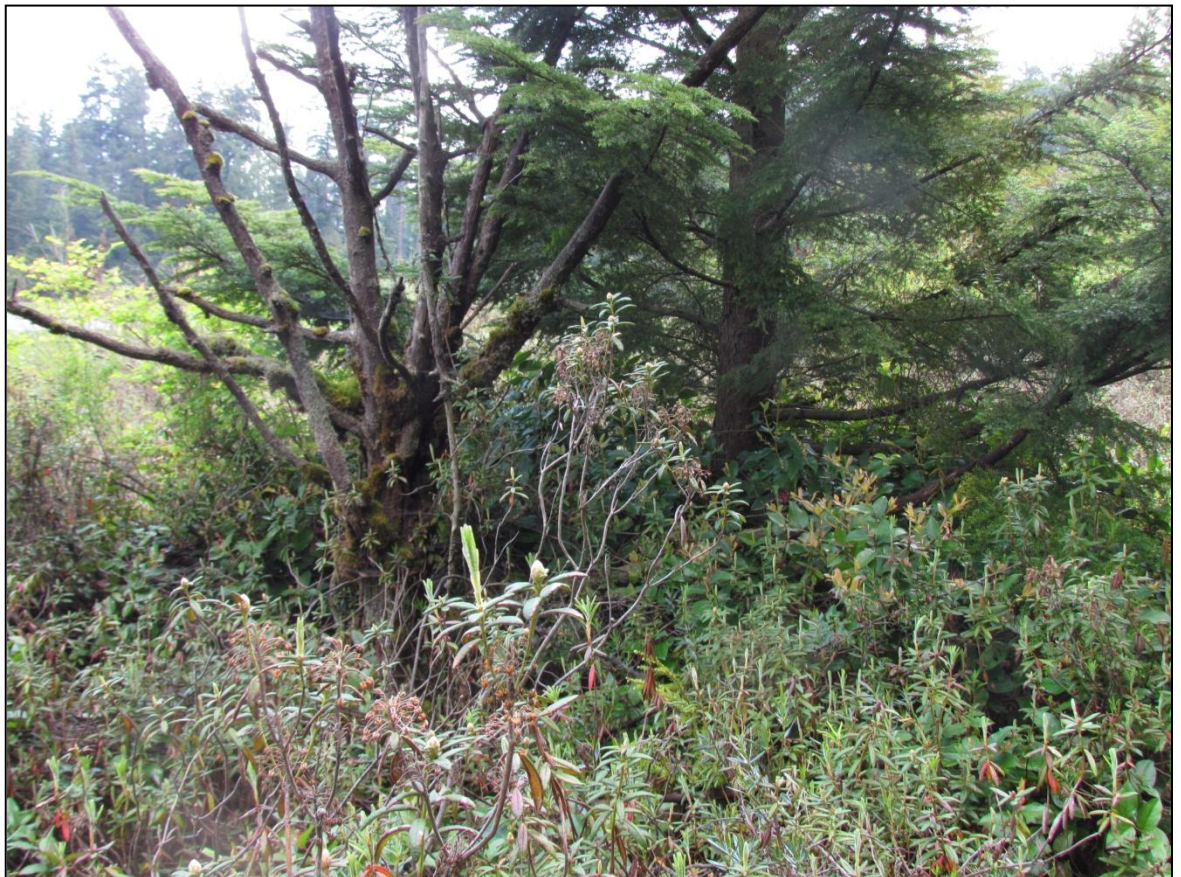
Figure 4: View of bog, facing north, in 2011. Although the bog laurel was in bloom there are few plants left in this area.

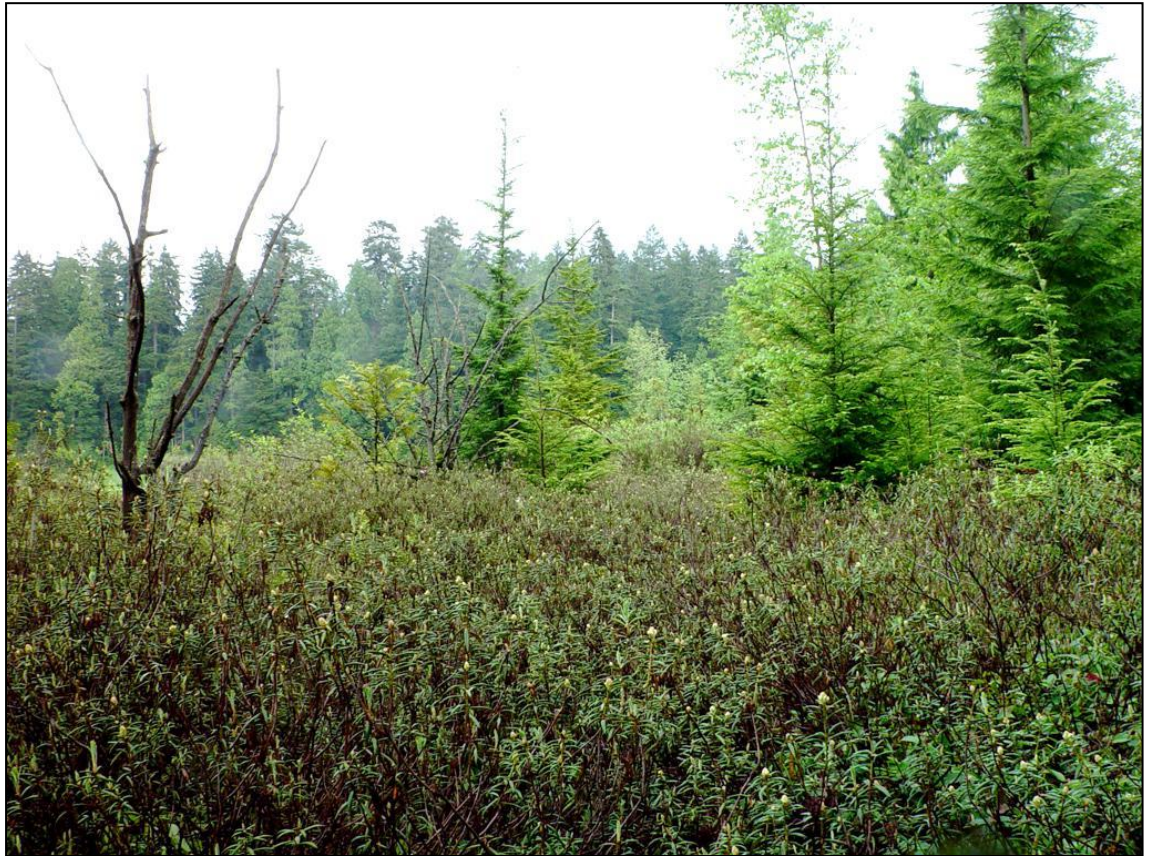
Figure 5: View of bog, facing northeast, in 2002. Note the small cedar in the foreground.

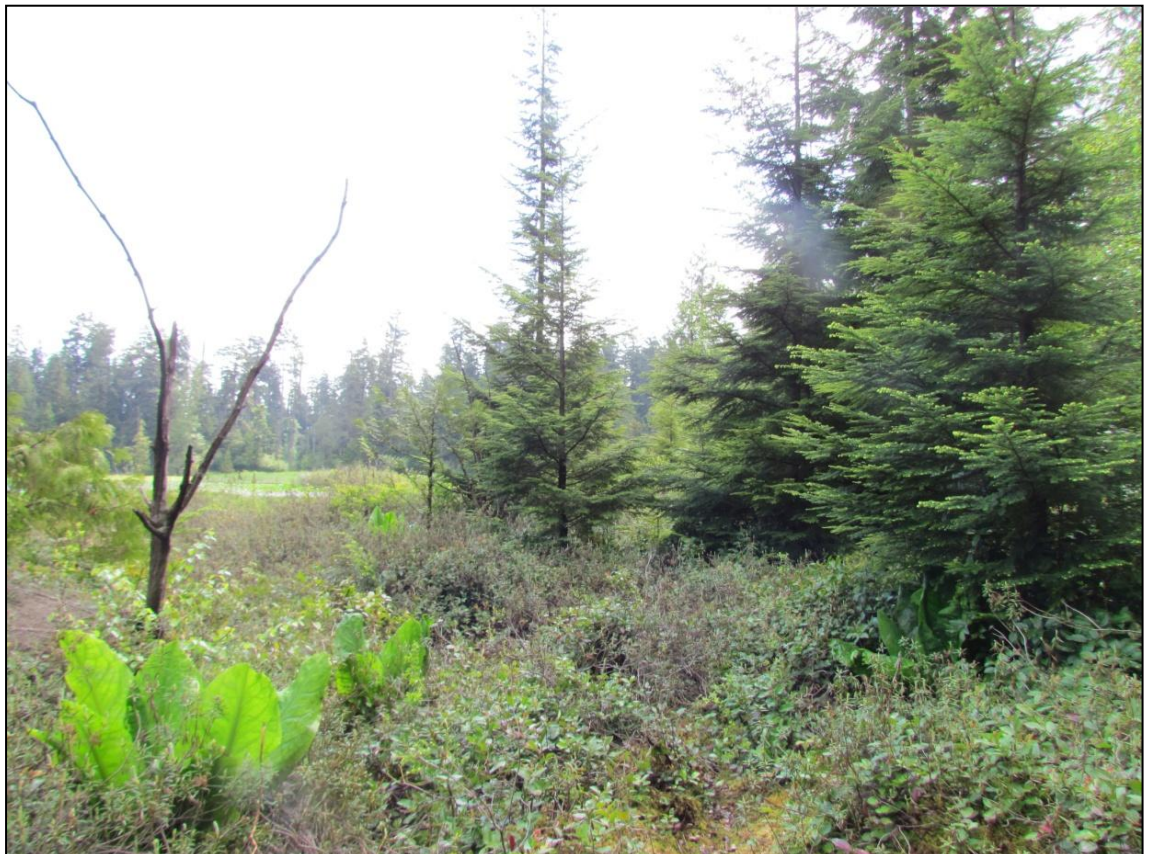
Figure 6: View of bog, facing northeast, in 2011. Note the growth of hemlock trees, the increase in salal and the appearance of skunk cabbage.

The current map of the bog as seen in Figure 2, shows some distinct changes to the bog area since the earlier study. In 1998, there were several large sections that contained predominantly bog laurel, but today there are only a small number of bog laurel plants scattered throughout those areas (see Figures 3 and 4). The 1998 map showed areas where there were several hemlock trees together on the southern edge of the bog, and today that area has been almost completely overtaken by a small stand of these trees (see Figures 5 and 6).

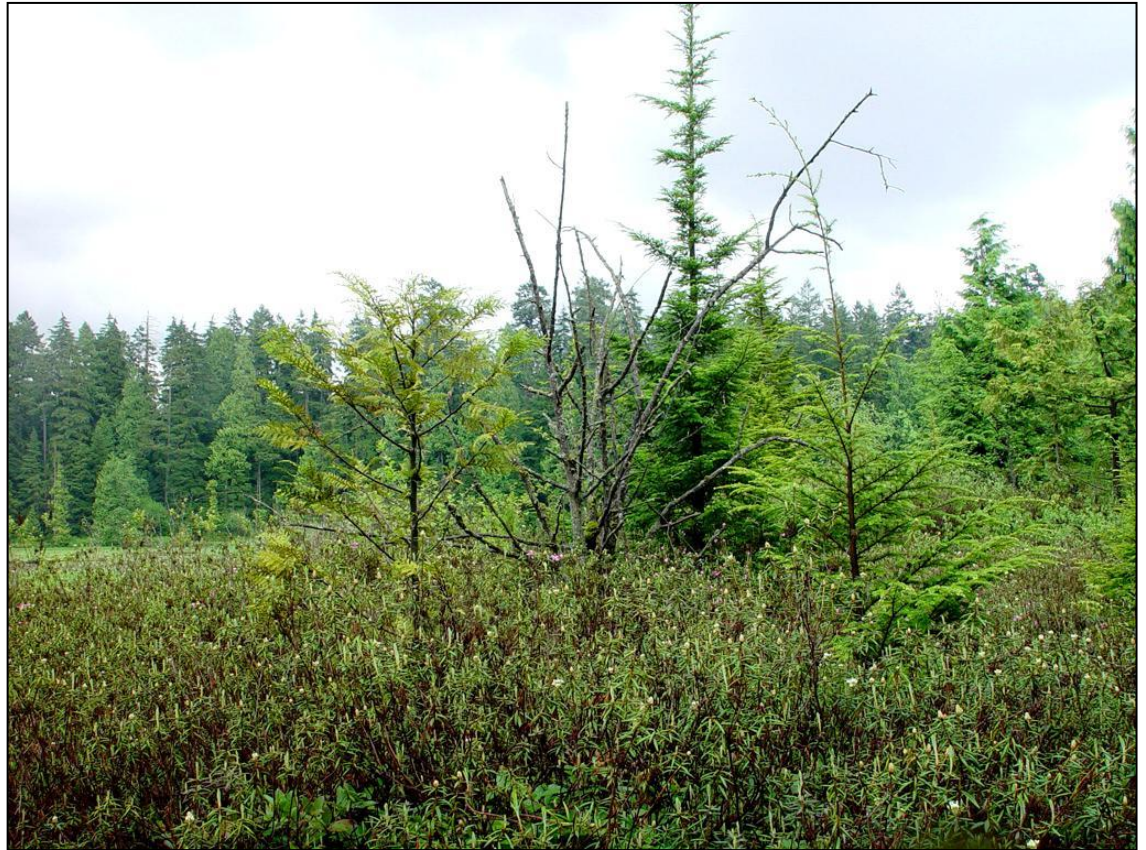
Figure 7: View of bog, facing northeast, in 2002. Note that the predominant shrub vegetation is Labrador tea.

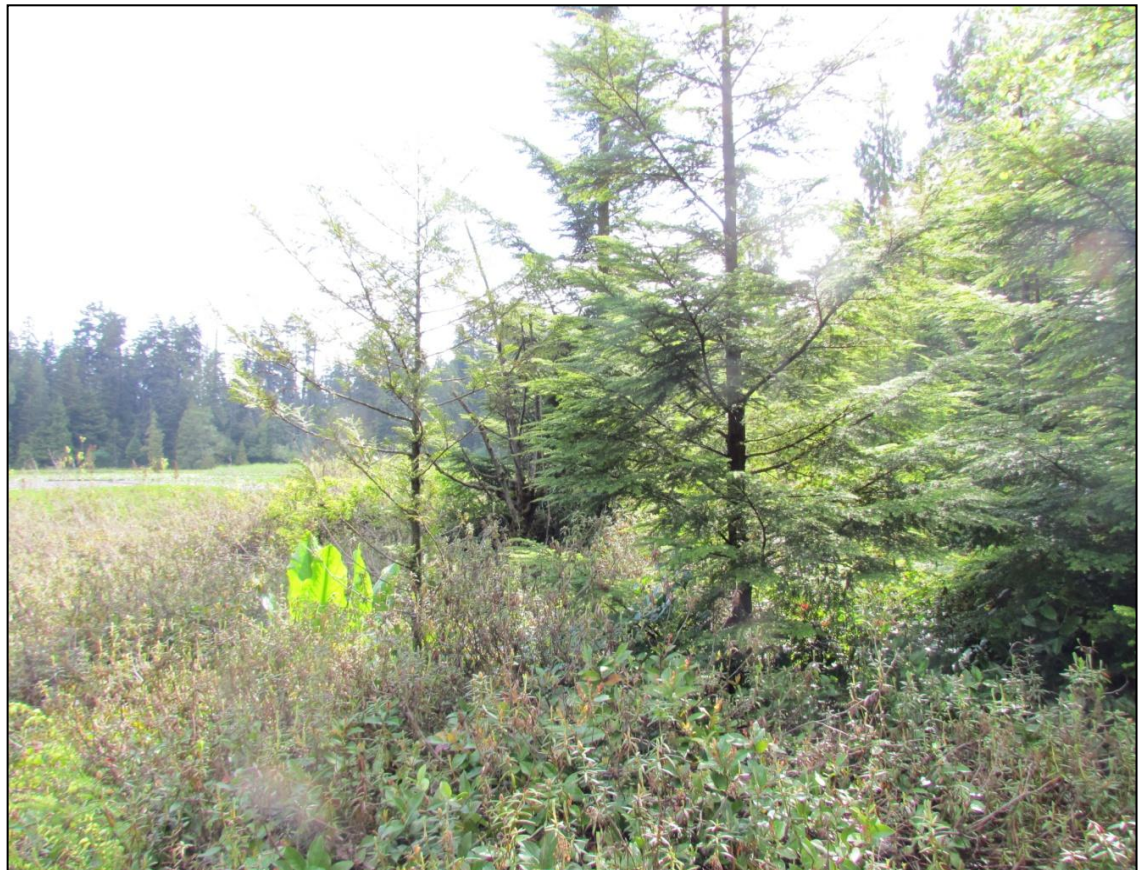
Figure 8: The same view of bog as in Figure 7 taken in 2011. Note that the predominant shrub vegetation is salal mixed with Labrador tea, the hemlock trees have filled in, and skunk cabbage has invaded (an indicator of nutrient rich soils uncharacteristic in bog habitats).

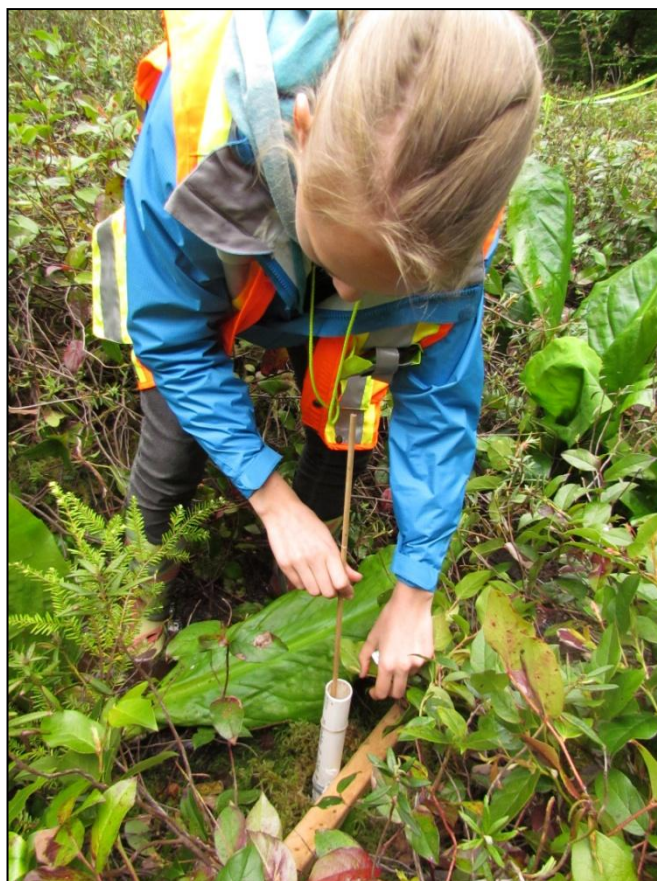
Young Naturalist and Generation Green Award recipient, Maja Lampa, checking water levels in the piezometer.

In addition to mapping the vegetation our team also installed a piezometer to monitor changes in the water table. Soil pH and nutrient levels will also be monitored throughout the project. Table 2 outlines out current list of wildlife species using the bog.

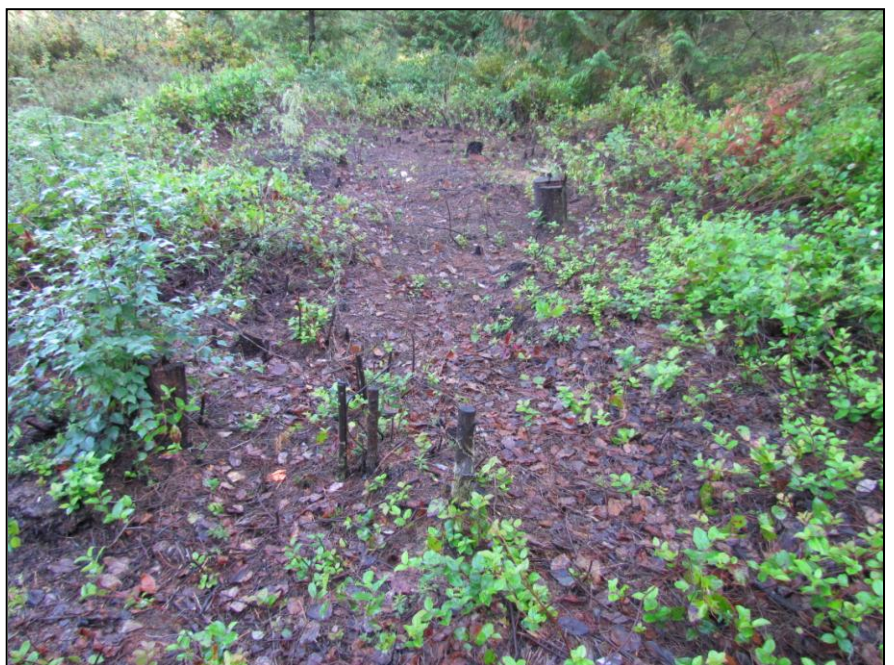
Figure 9: This is the area once occupied by hemlock trees in the bog. Once the trees were

felled, the underlying area devoid of vegetation became exposed.

Through the in-kind service of the Vancouver Park Board forestry staff, trees in the bog that had been identified by SPES as negatively influencing the bog by shading out bog species and occupying bog habitat were felled by chainsaw, and bucked up for removal (see Figure 9). The felled and bucked trees were left on site.

After the trees were felled, a community group was brought into the bog by SPES to manually remove the material to areas outside of the bog. Parts of these felled trees were used to build temporary bridges and access paths throughout the bog to allow easier access for future restoration work and to minimize trampling of the sensitive bog species.

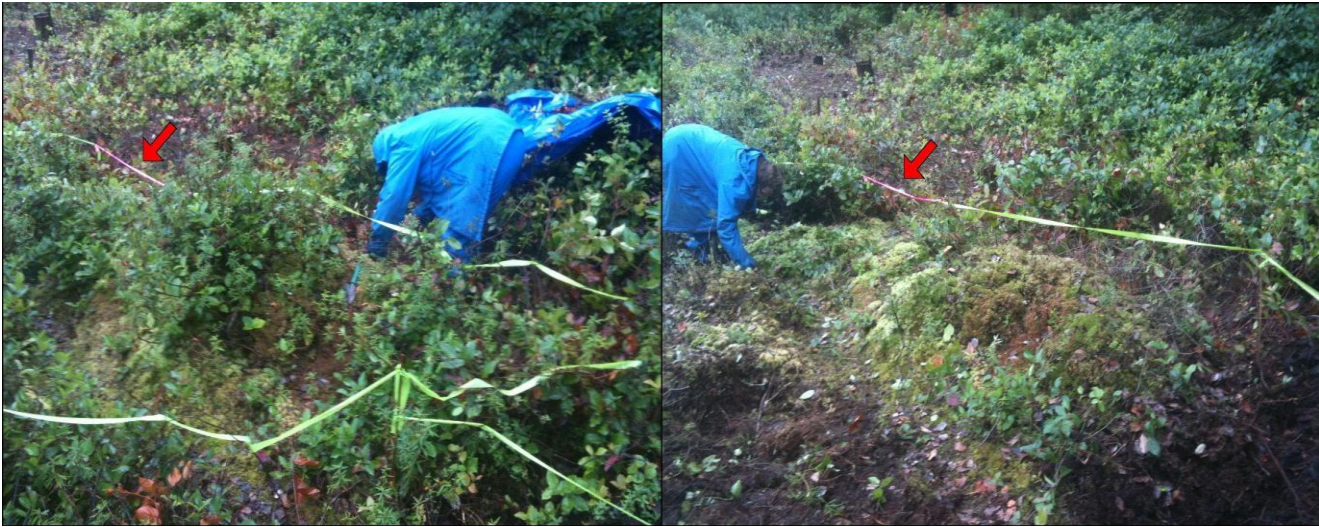
Figure 10: Before and after pictures showing a work group's progress at removing invading salal and Labrador tea and exposing the sphagnum hummock below. Note the pink flagging tape (red arrow) as a reference.

Removal of salal and Labrador tea are performed by voluntary work groups of youth and adults brought into the bog by SPES staff. Groups of 6-10 individuals at a time are ideal to minimize trampling of sensitive areas and species. Once the plant material has been removed from the bog it is stored nearby in the forest. After several sessions the plant material is brought to Beaver Lake trail where it is picked up by the Park Board staff for disposal (see Figures 10 and 11 for before/after photos of shrub removal).

- Using hand pruners, clip several centimeters above the ground to remove the top of the plant and expose the ground below.
- If sphagnum hummocks are present:
 - gently pull out the stems and roots, trying not to displace large chunks of the fragile moss.

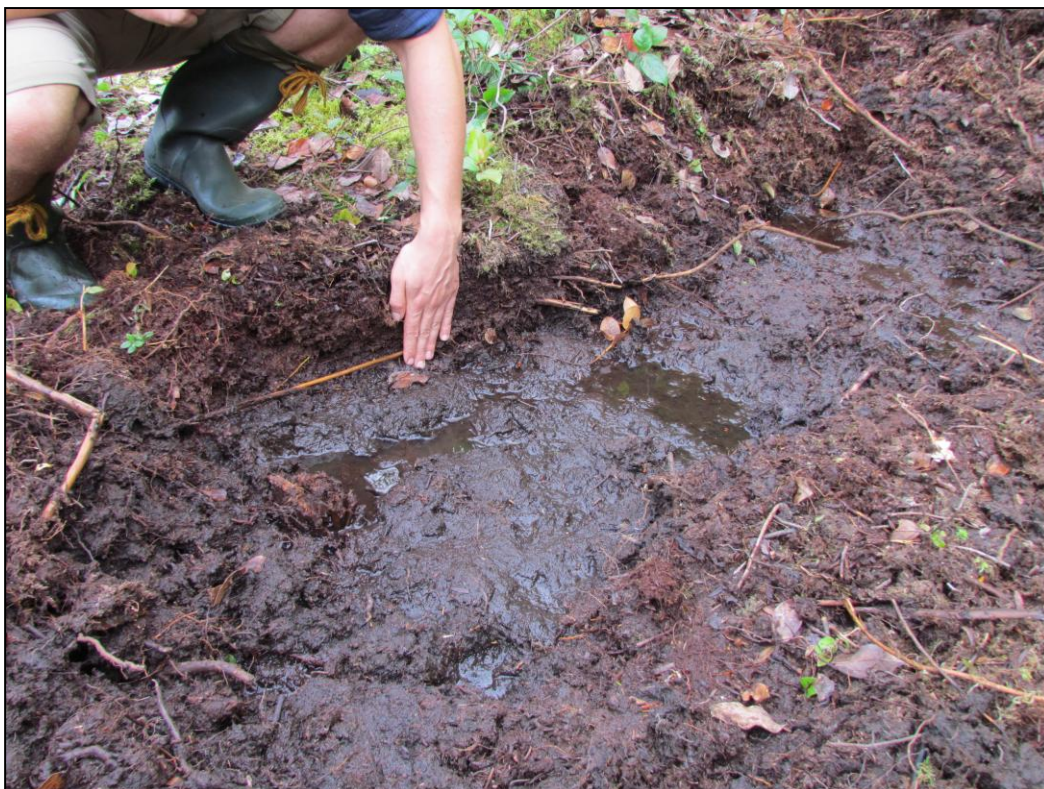
Figure 12: Area where the organic debris has been removed down to the layer of peat.

To create ideal growing conditions for native bog plants this layer of organic matter must be removed to expose the slowly decomposing and waterlogged sphagnum below (see Figure 12). This is most easily accomplished by the use of the Pulaski axe.

- Using the axe end of the tool cut down into the organic debris until the peat is reached.
- Continue cutting a line at this depth for a total length of about 30 cm and then proceed to make an additional cut parallel to this about 45cm apart.
- Connect the two at the top of these incisions with another cut so that you've cut in 3 sides of a square or rectangle.
- Using the pick end of the tool pry under the top cut and work at peeling the organic debris back in a large section much like rolling up a carpet.
- The layer of organic debris, while heavy, should peel back from the peat fairly easily as it is only resting on top of it (Laurence Brown, pers. comm.).

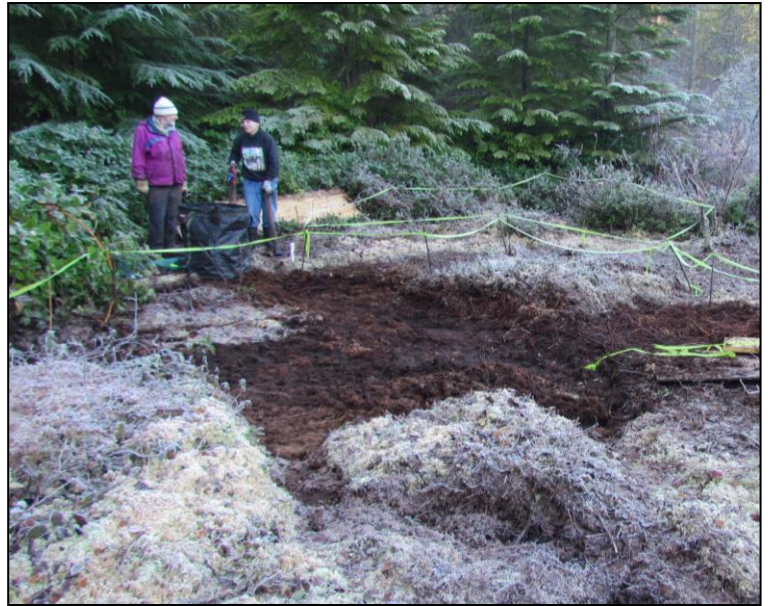
The original planting area has been expanded and levelled to the ideal height for transplanted sphagnum moss.

In mid-December of 2011 members from the Camosun Bog Restoration Group examined the test site and helped to determine which level of peat height resulted in ideal growing conditions for the sphagnum. Once the ideal height was determined the remaining area was leveled to the same height. Work has since taken place by community groups to expand this area so that it can be planted with sphagnum plugs. All of the areas in the bog not colonized by sphagnum moss, bog laurel or round-leaved sundew will be cleared and leveled to this optimal growing height. This includes sphagnum hummocks that are colonized by

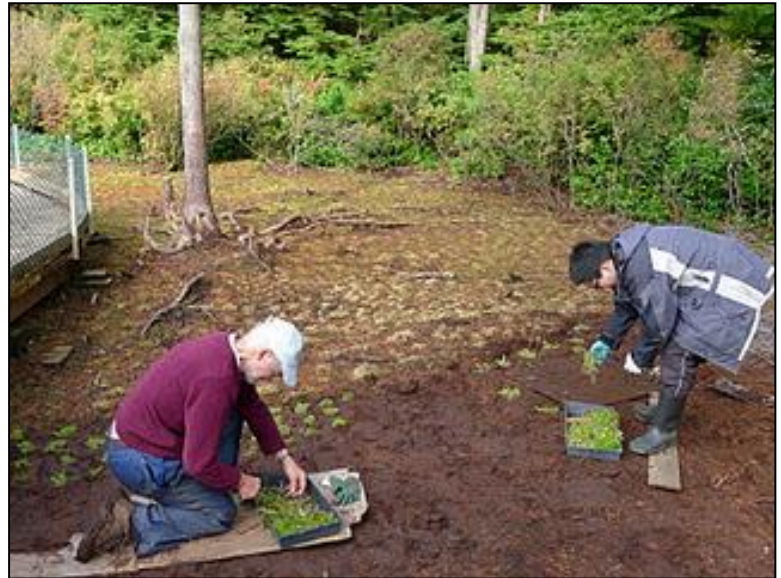
Volunteers at Camosun Bog transplant sphagnum plugs along a grid pattern. (Source: <http://camosunblog.blogspot.com/>)

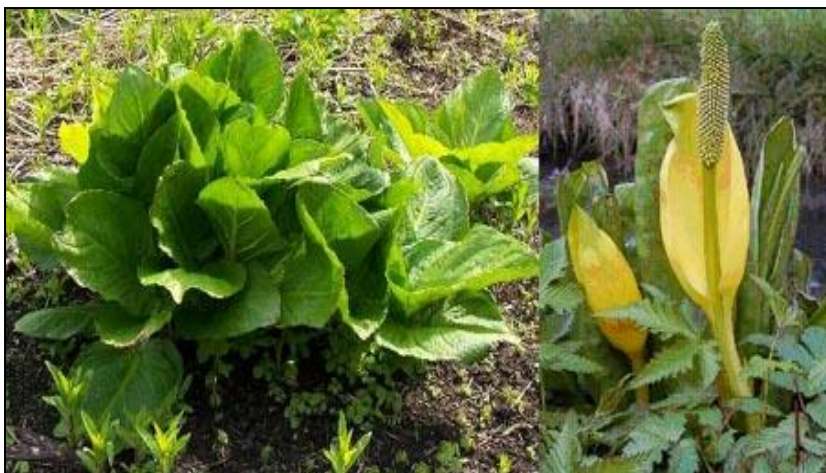
Skunk Cabbage (*Lysichiton americanum*)*

General: Robust, hairless perennial 30 – 50 cm tall. Grows from a fleshy, upright underground stem. Gives off a skunky odour especially when flowering.

Leaves: In large basal rosette, lance-shaped to broadly elliptic, often huge (up to 1.5 m long and 0.5 m wide). Thin and net-veined, tapering to short, stout, winged stalks.

Ecology: Found in swamps, fens, muskeg, wet forest, mucky seepage areas, wet meadows at low to middle elevations.

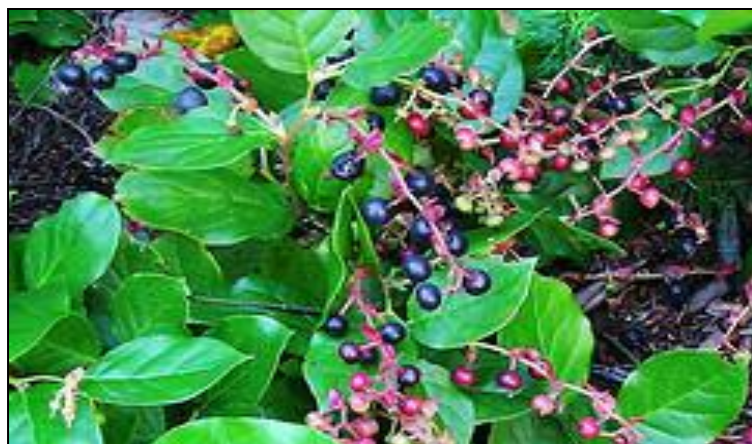
Salal (*Gaultheria shallon*)*

General: Creeping to erect; spreads by layering, suckering and sprouting. Height variable between 0.2-5m tall with hairy, branched stems.

Leaves: Alternate, evergreen, leathery, thick, shiny and egg shaped. 5-10cm long, sharply and finely toothed.

Flower/Fruit: White or pinkish urn shaped 7 – 10mm in length. 5 – 15 at the end of branches, flower stalks bend so that all flowers orient in same direction.

Ecology: Found in coniferous forests, rocky bluffs and near the sea shore at low to medium elevations.

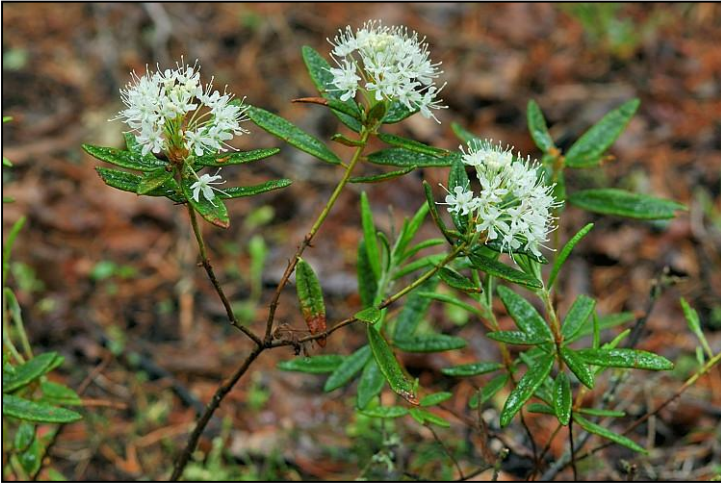
Labrador Tea (*Rhododendron groenlandicum*)

General: An evergreen shrub, to 1 m tall, young twigs densely hairy, becoming smooth (glabrous) in older stems; flower bud large, terminal.

Leaves: Alternate, simple, 2-5 cm long and 0.5 to 2 cm wide, short-petioled, evergreen, fragrant when crushed. Blade oblong-elliptic, leathery-textured (coriaceous), dull and dark green above, lower surface covered at first with dense white hairs that become rusty-coloured in mature leaves; margins entire and strongly curved under

Ecology: Found in moist to wet, peaty soils, especially bogs and wet coniferous forests.

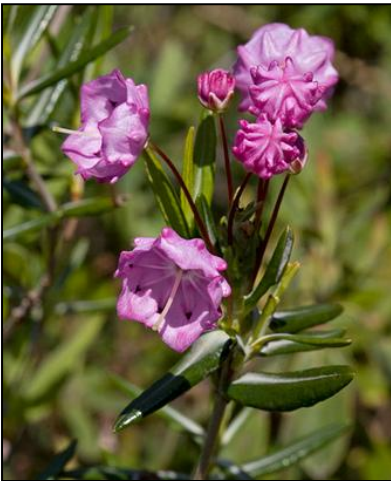
Western Bog Laurel (*Kalmia microphylla*)

General: Small, slender-branched evergreen, up to 0.5 m tall; spreads by layering and short rhizomes.

Leaves: Opposite, narrowly lance-shaped up to 4 cm long; margins rolled under; dark green and leathery above, conspicuously whitish and fine-hairy beneath. Compared to Labrador tea, bog laurel leaves tend to point more upwards, are darker green above and are less curled. The hairy/fuzzy underside of bog laurel is more whitish in appearance compared to Labrador tea which is browner underneath.

Ecology: Found in bogs and wet mountain meadows.

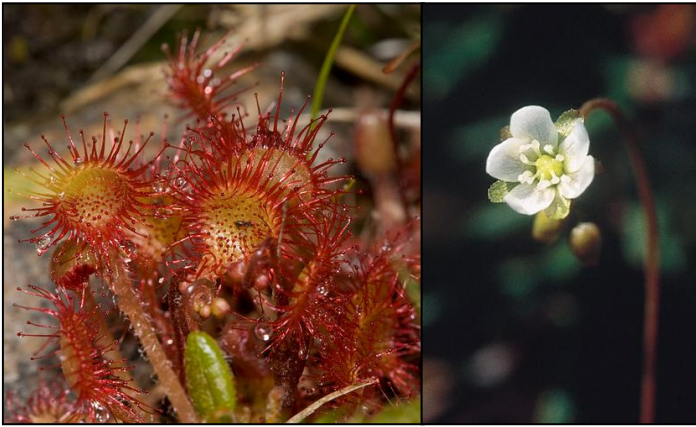
Round-leaved sundew (*Drosera rotundifolia*)

General: Small, insect-eating perennial, 5 – 25cm tall. Appear to be covered in ‘morning dew’ at all times.

Leaves: Sticky, glandular, spreading in basal rosette 3 – 7cm long. Blades round to broadly egg shaped, at least as broad as long. Fringed with long, reddish, glandular hairs that exude drops of sticky fluid.

Ecology: Found in sphagnum bogs, fens and wet meadows at low to middle elevations.

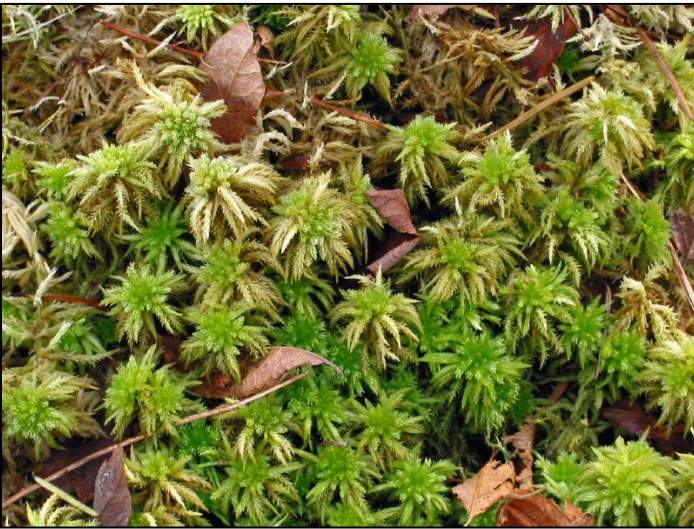
Peat Mosses (*Sphagnum spp.*)

The genus sphagnum (the peat mosses) contains about 40 separate species in coastal BC that live in forests, cliff-faces, bogs and fens. They have a number of different features that make their morphology distinct and their identification to the species level difficult.

The branches occur in clusters each with some branches spreading at 90 degree angles and the remainder hanging down the stem. The stems are upright and in addition to the clusters of branches, have stem leaves. These are critical to the identification of most species.
